REPORT NO : VT-151005-5

SPECIMEN : SR200、SR700

TEST / INSPECTION ITEMS : Vibration Test

TESTING / INSPECTION REPORT

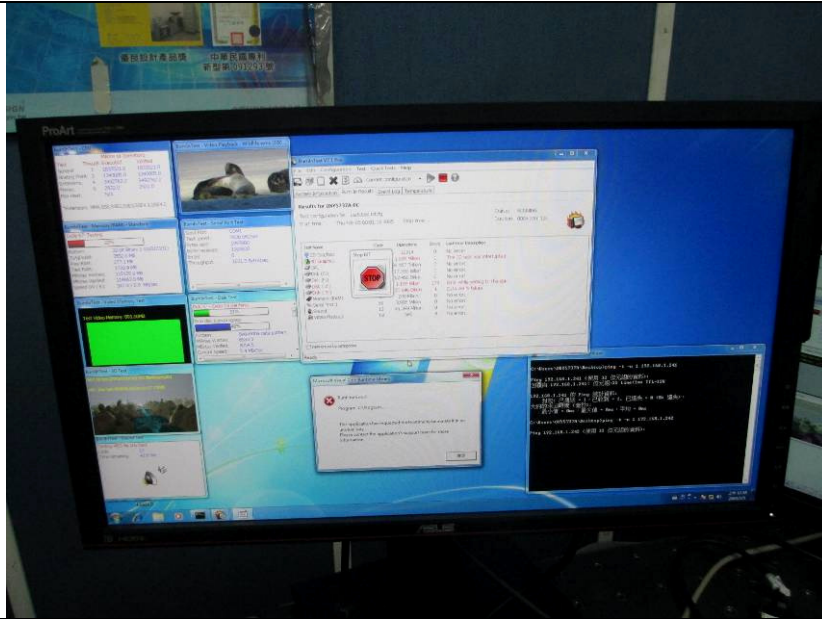
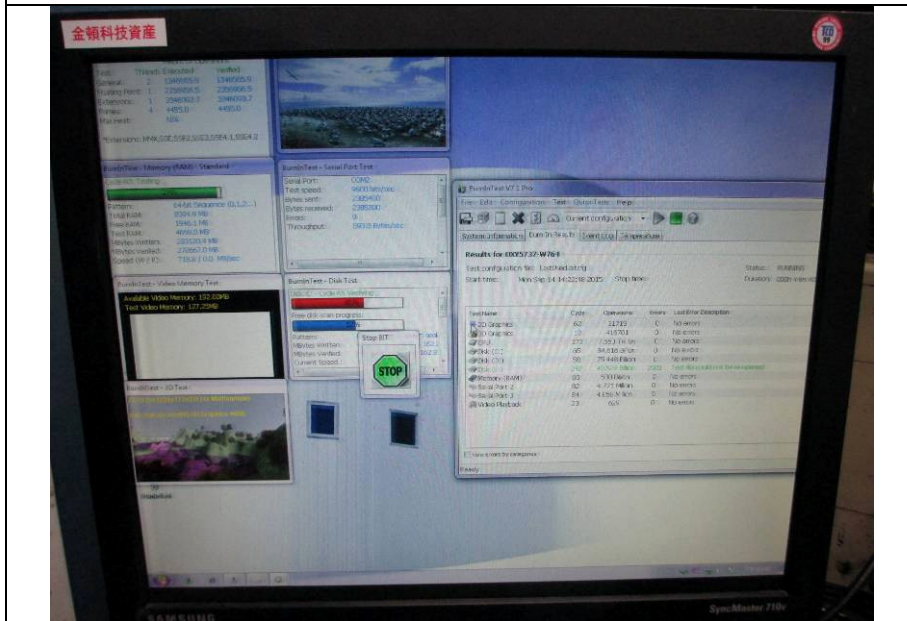
After test

Describe	PASS ⁽¹⁾	FAIL	Non-Judgment
Function judgment	√	— —	— —
Appearance check	√	— —	— —
(1)-- After completely testing, visual inspection showed no physical defect on unit. Power and interface operation was normal.
